PERRY CITY DAM NO. 2
RALLS COUNTY, MISSOURI
MO. 10980

PHASE I INSPECTION REPORT
NATIONAL DAM SAFETY PROGRAM

Name of Dam: Perry City Dam No. 2, Missouri Inv. No. 10980
State Located: Missouri
County Located: Ralls
Stream: Mace Branch of Lick Creek
Date of Inspection: July 12, 1980

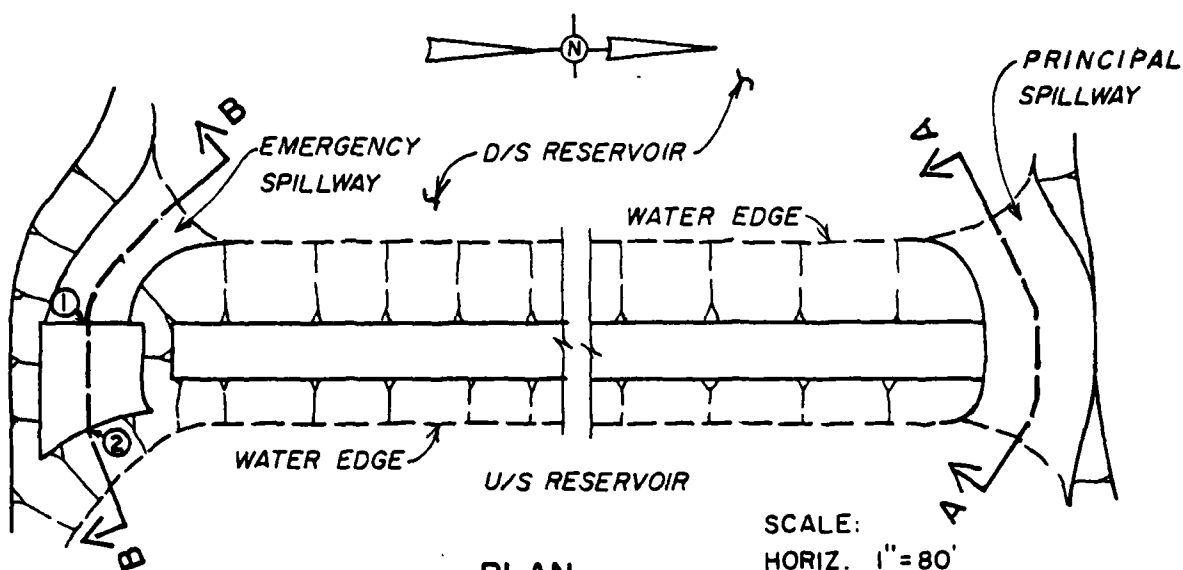
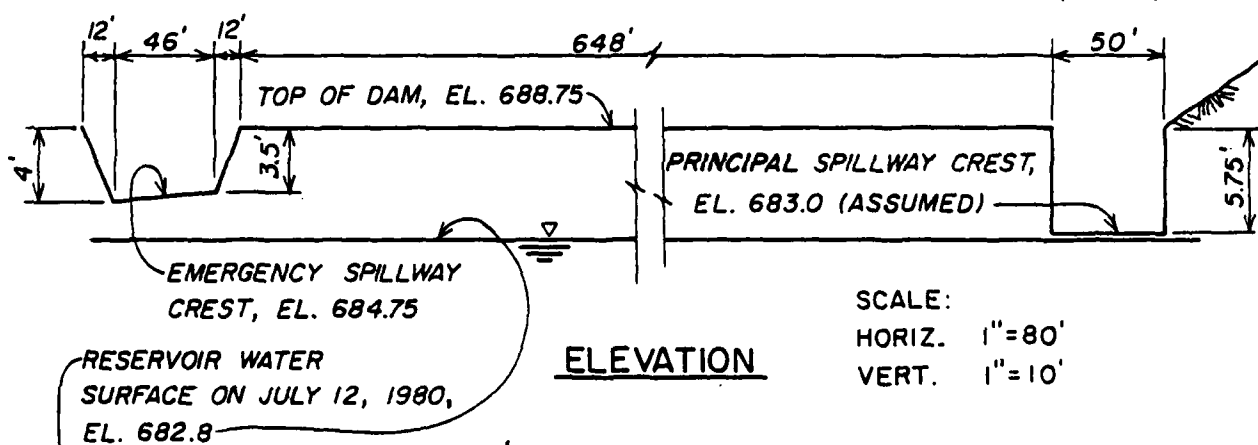
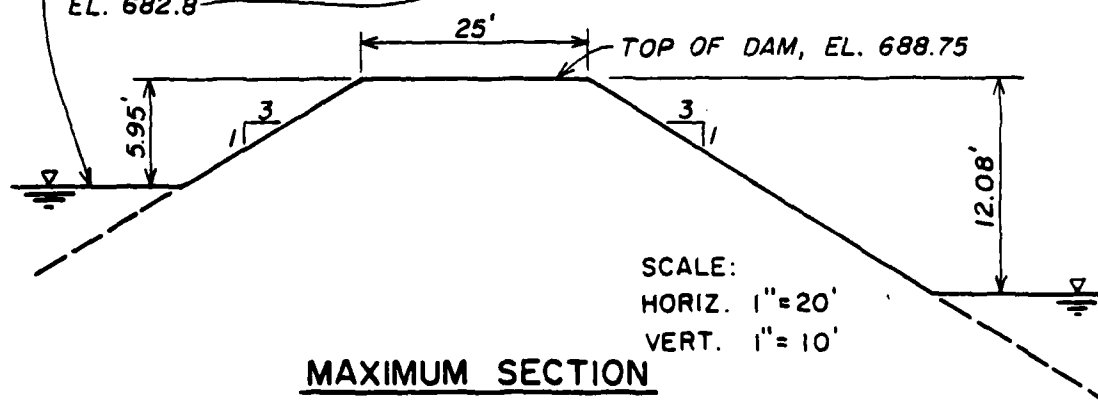
PERRY CITY DAM NO. 2 (MO. 10980)
PLAN, ELEVATION &
MAXIMUM SECTION OF EMBANKMENT

The dam is a rolled earthfill structure with a straight alignment between earth abutments. A plan and elevation of the dam are shown on Plate 2 and Photos 1 through 3 show views of the dam. According to the drawings, the embankment was supposed to be zoned; however, according to Mr. Elliot, the dam is homogeneous and not constructed with three different zones. The dam was constructed with a cutoff trench extending at least 2 feet into the foundation soils. Plans noted a thin surficial silt layer beneath the dam.
